January 17-19, 2024 40th CRCA Trade Show & Seminars

Low Rise Adhesive Foam Current Issues and Joint CRCA/NRCA Research

Matt Dupuis PhD PE SRI Consultants

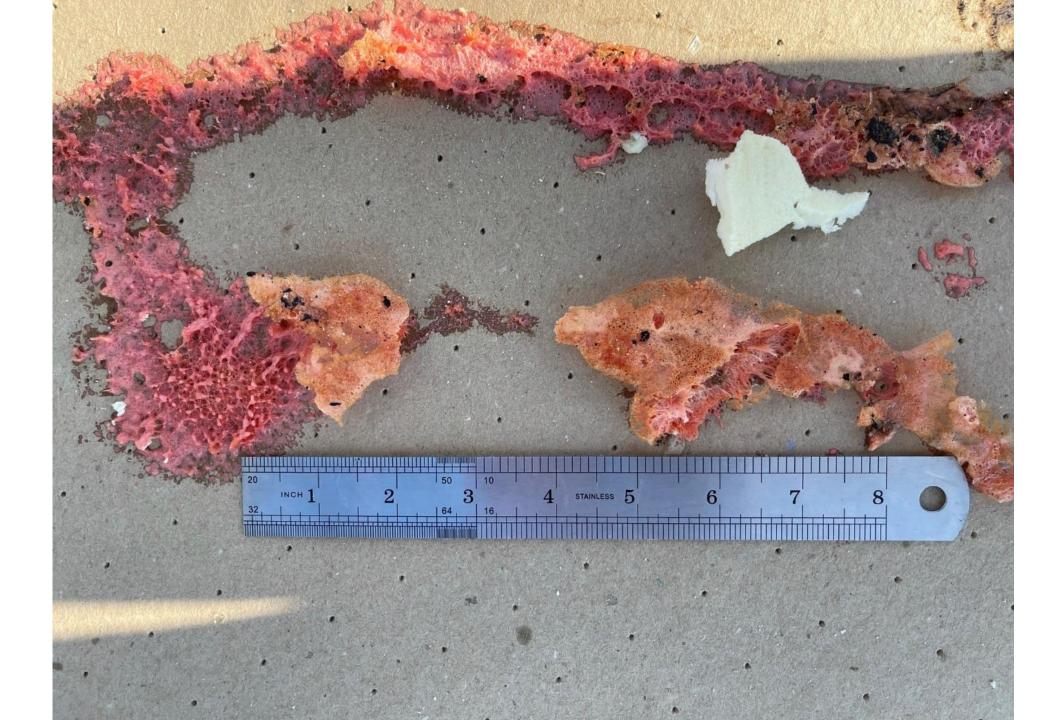
- Off Ratio A Bias (too much A)
 - Hard, brittle and glassy foam
 - Can have extremely low strength
- In the field it will "crunch" under thumb pressure
- "Crispy"

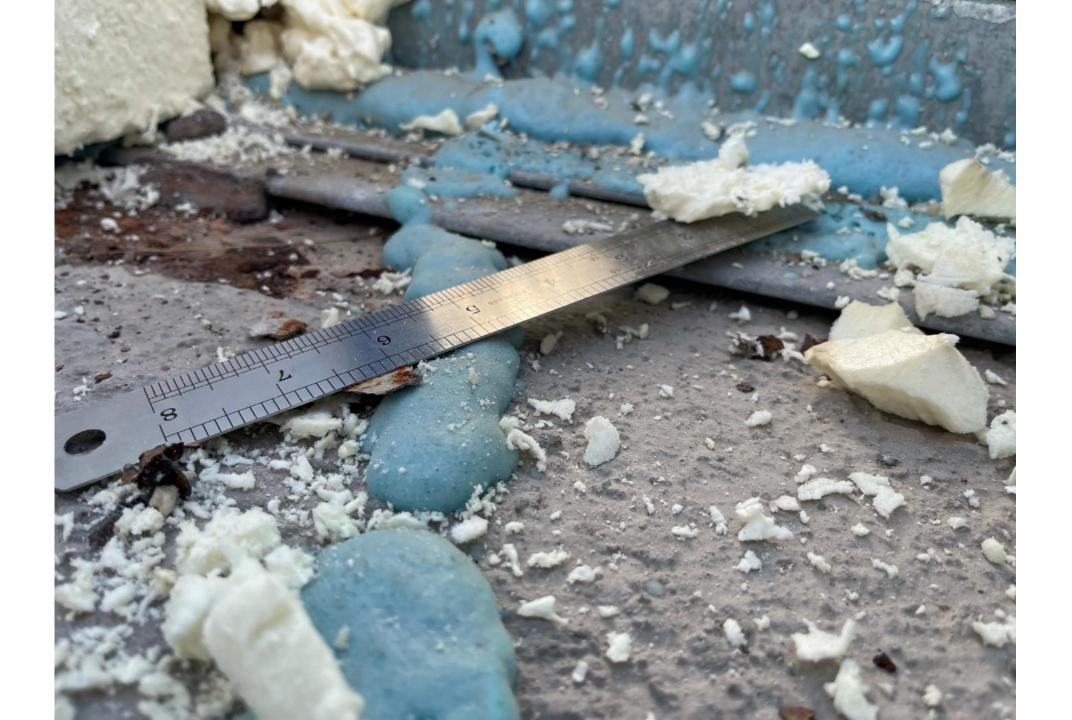
- Off Ratio B Bias
 - Soft and doughy consistency
 - Tends not to bond at all, it is present but doesn't adhere.
 - Consistency under pressure from thumb is similar to memory foam or worse, just a souffle like mass that will collapse to nothing under pressure

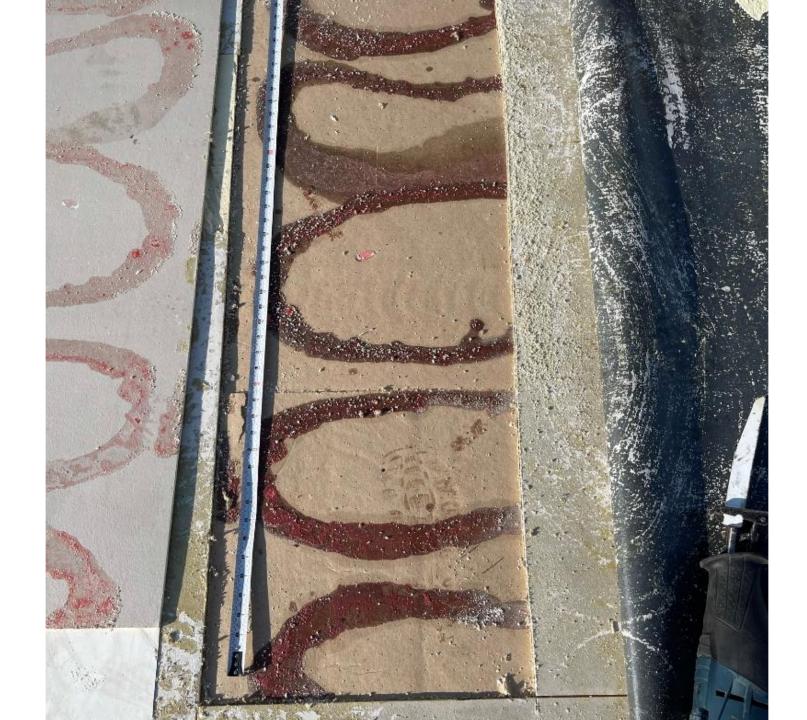
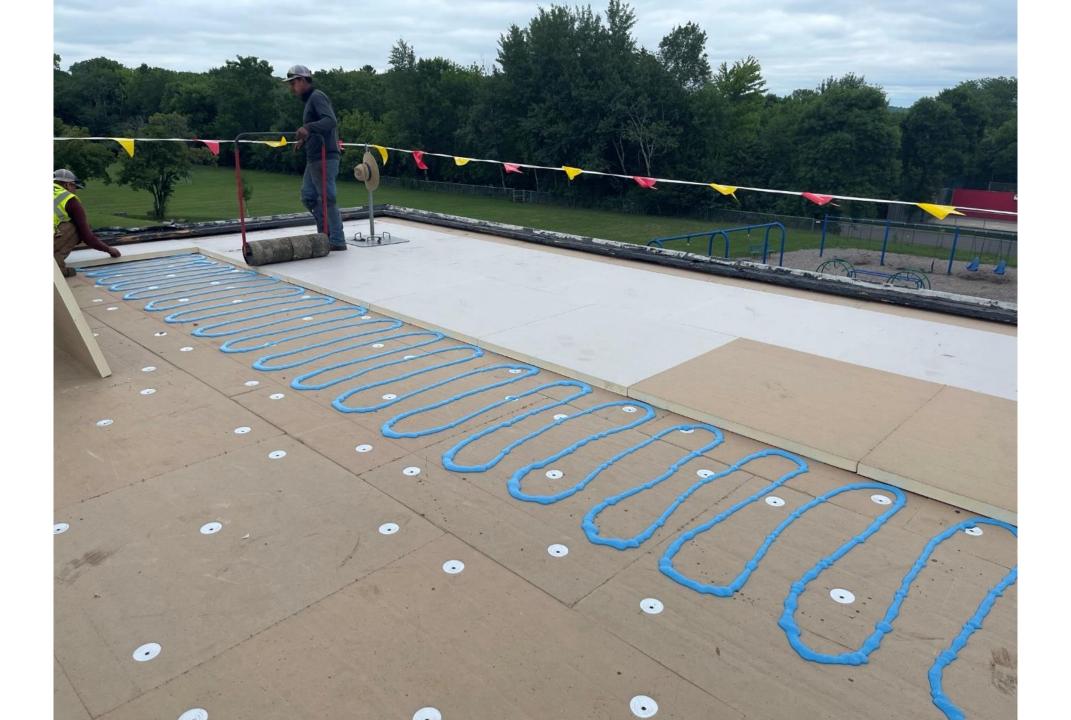
- Unreacted A and or B components
 - Unmixed or massively off ratio
- Unmixed, massively off ratio possible bad product
- Result is zero bond
- Forensically will have the consistency of maple syrup or honey
 - Tacky
- Field staff should see this as it doesn't react...

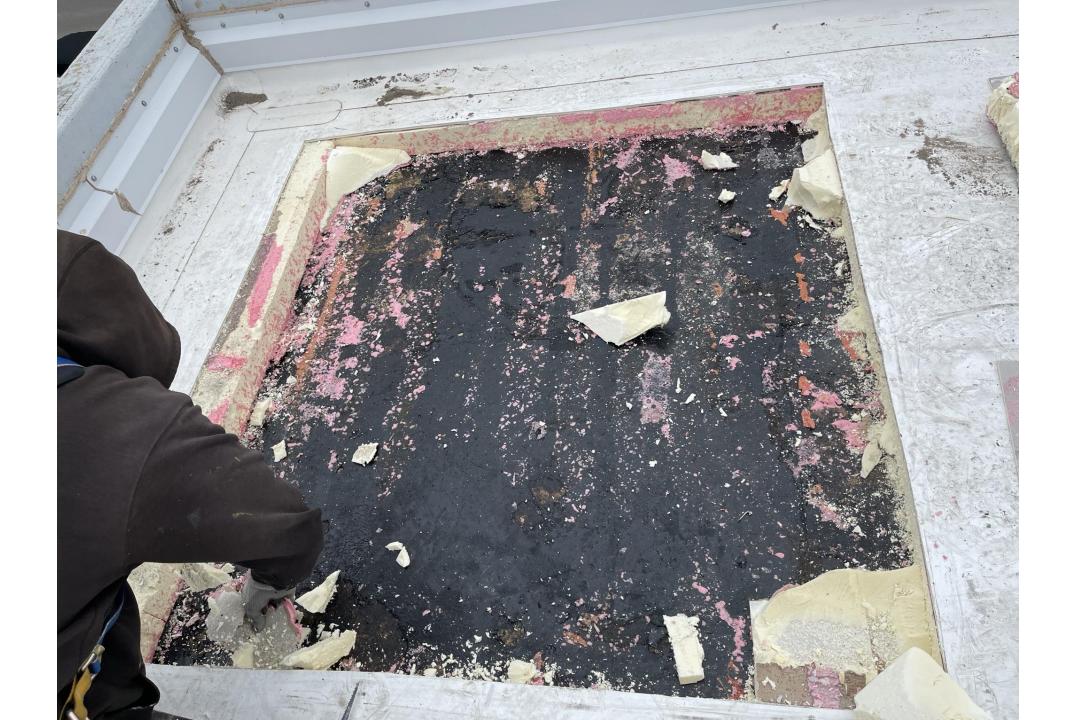
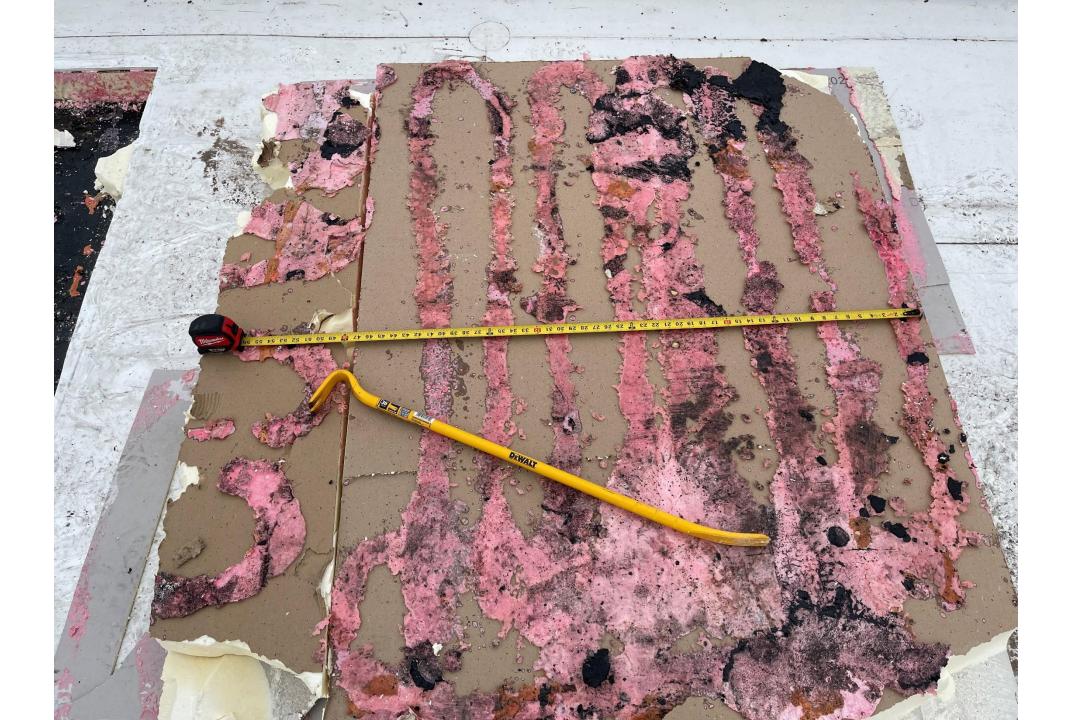
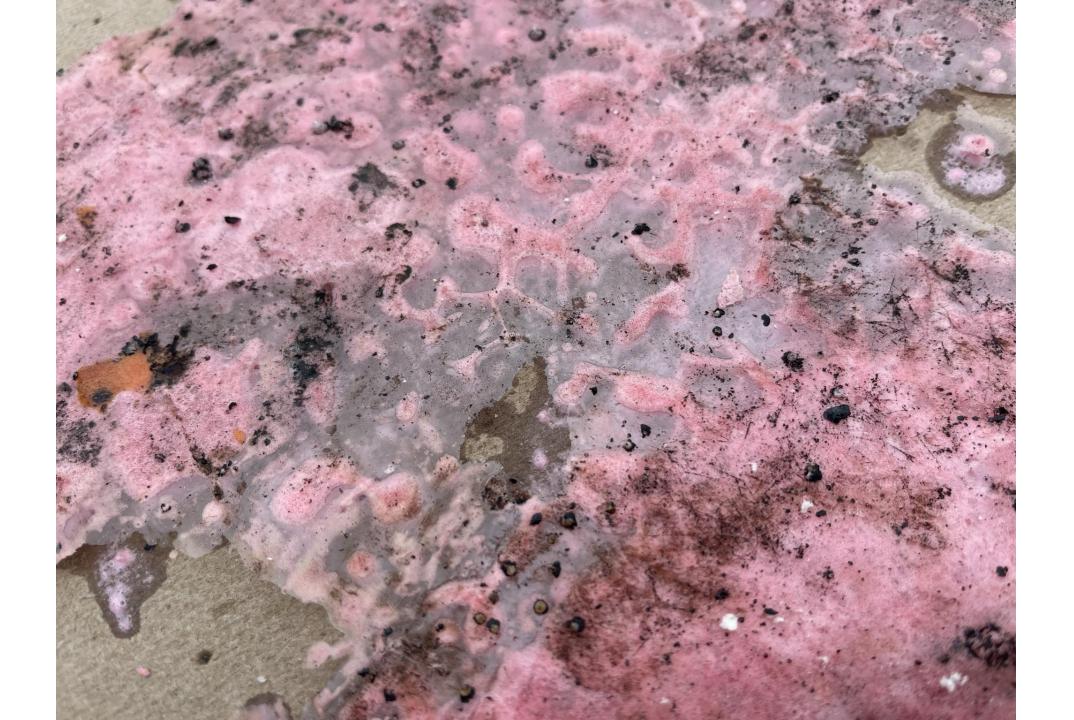
- Does not stick to asphalt!!!
- FM Roof in Texas
 - Contractor could not pass uplift testing
 - 120PSF target -> 35 PSF failure
- Forensic cuts showed a bond break at old BUR on concrete deck
 - Spudded off (Spud Bar)
- Manufacturer contacted foam manufacturer
 - "Well yes, our foam doesn't stick to fresh asphalt. Didn't we tell you?"
- Current foam kits now say
 - "Prime previously unexposed asphalt"

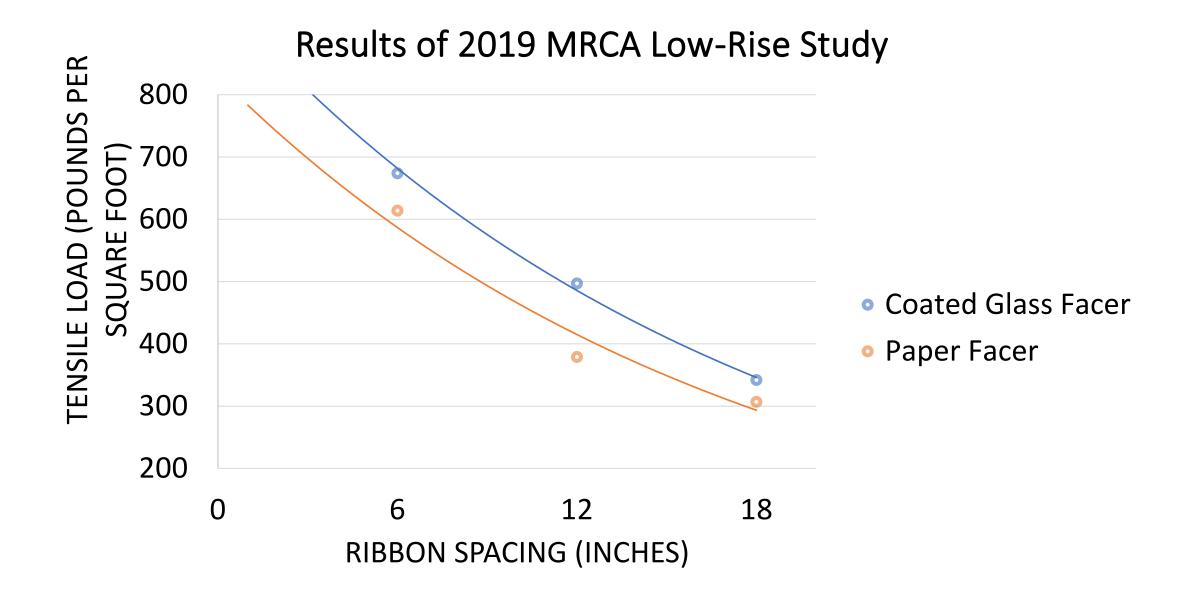
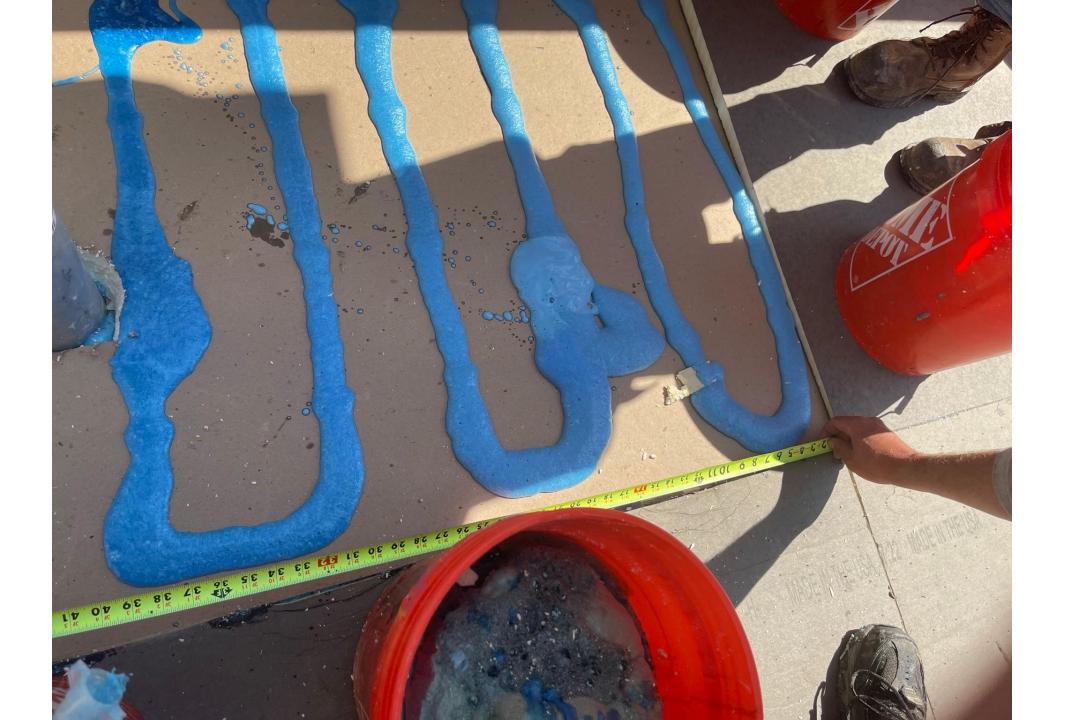
- A custom metal plate was bonded to polyisocyanurate flat stock and then separated with a load frame in tension.
 - One manufacturer of adhesive
 - Ribbon spacing 6, 12 and 18 inches
 - Paper Facer and Coated Glass Facer

- Consider maximum uplifts in wind ratings (FM) go to just over 300 PSF
- Failure point was always in the polyisocyanurate core
 - Not cohesive or adhesive for the low-rise foam
- Begs the question of condemnation of a roof system for adhesive ribbons that are slightly out of specification...

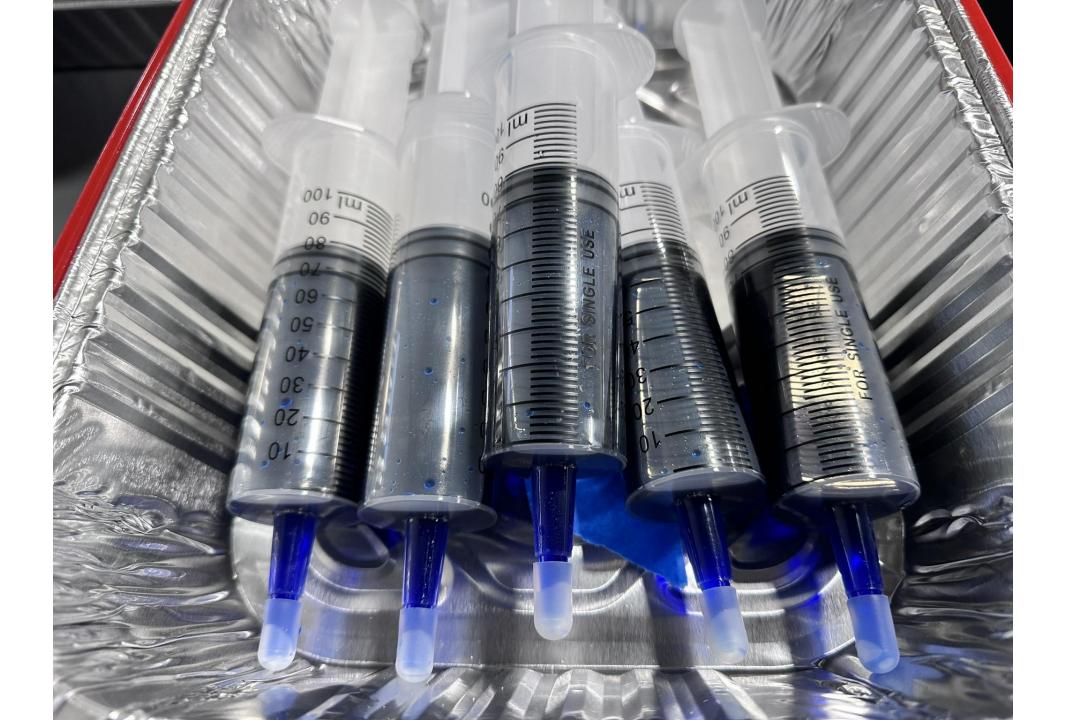
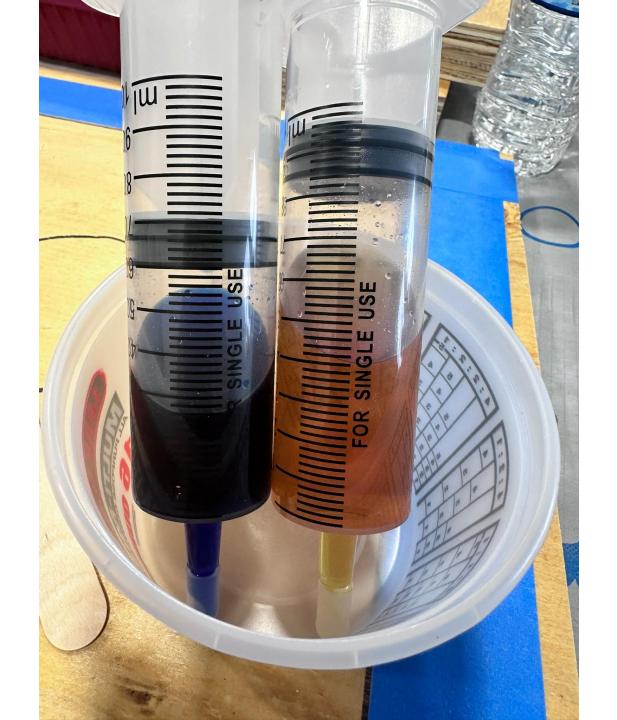
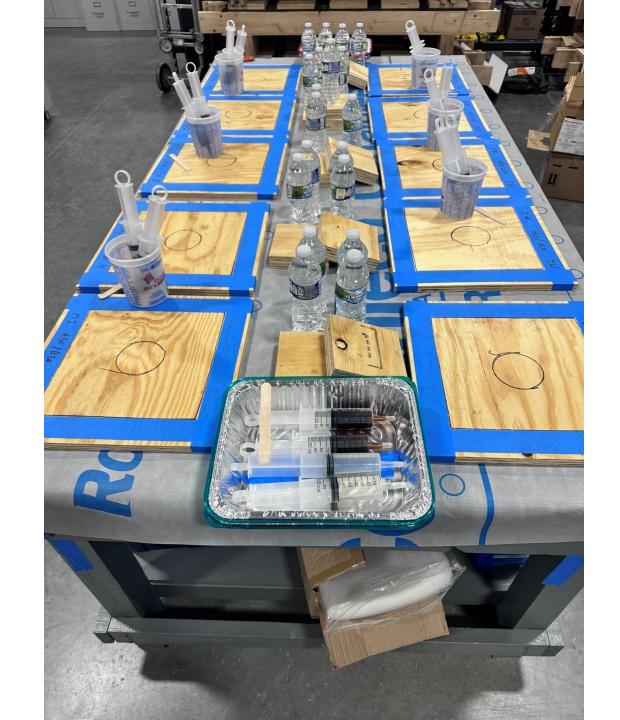
- Capped and graduated syringes were drawn from larger samples of bulk kits
- Five replicates of each ratio + manufacturer
 - 70 total tests
- A+B mixed and stirred vigorously
- Applied mixture allowed to react ("kick")
- Plate applied with weight for 1 hour
- Allowed to cure a minimum of 24 hours before pulls
- Microscope slides prepared of each mix

- Purpose: To test the strength of low-rise adhesive foam against A/B mixing ratio
 - Manufactured intent is 1:1 or 50/50
- Use a reaction frame for a bonded plate test.
 - CDX Plywood to CDX Plywood
- 6 inch by 6 inch plate
 - Converted and tared for Pounds per Square Foot
- Acquired two different kits from distribution in the Chicago area
 - Blue color (Manufacturer 1)
 - Yellow color (Manufacturer 2)
